# Residential Solar Panel Inspection

07/07/2025 11:34 AM

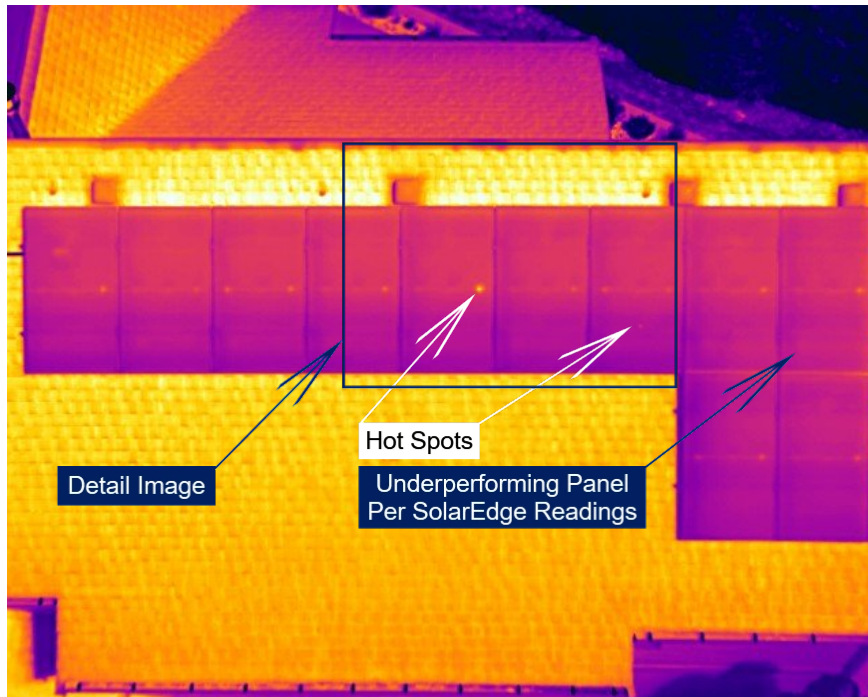
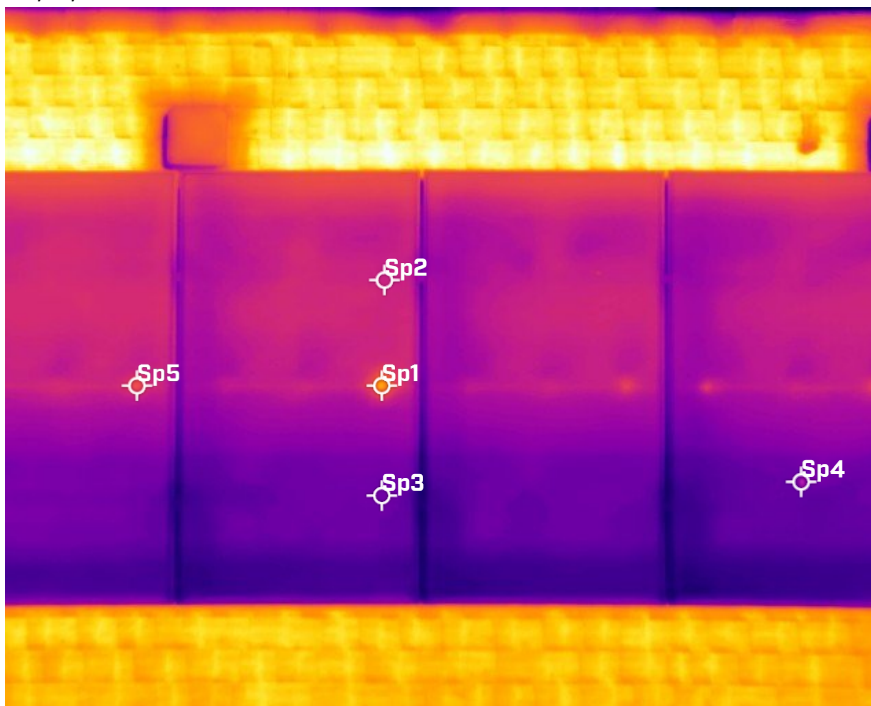
07/07/2025 11:34 AM

Spot 1, is likely a connection location and stands out as hotter than average.

Spot 4, is a soil spot but does not appear to be affecting the panel significantly.

| Sp1 | 160.5 °F |
| Sp2 | 130.2 °F |
| Sp3 | 121.8 °F |
| Sp4 | 129.8 °F |
| Sp5 | 137.9 °F |

Note: Temperatures listed are relative to this image
